Survey of Long-Term Durability of Fiberglass-Reinforced Plastic Structures

Seymour Lieblein
Technical Report Services

January 1981

Prepared for
National Aeronautics and Space Administration
Lewis Research Center
Under Purchase Order C-39549-D

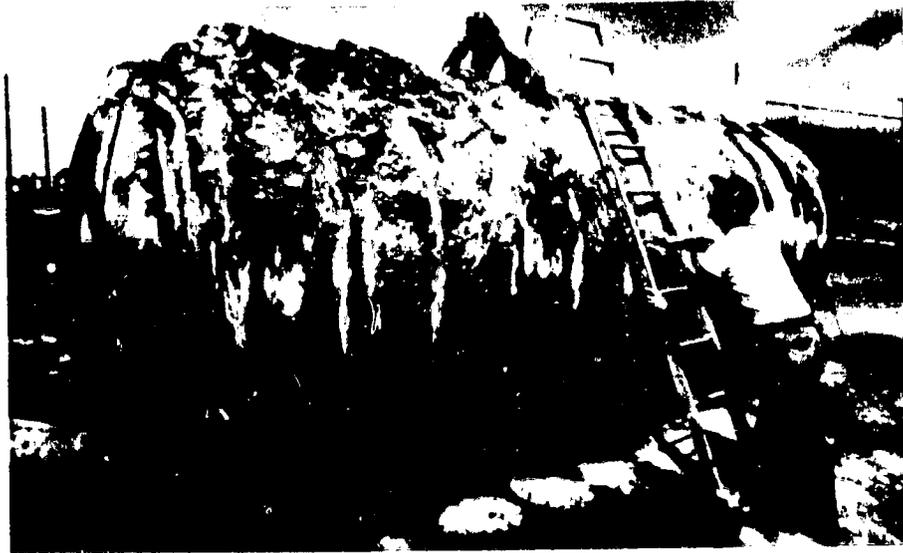
Figure 18. Effect of wind abrasion on fine sterile tent material after 10 years of service (photo courtesy of Owen Corning Fiberglas Corp.)

Tank after nearly 13 years. - The second tank, which was installed in Stony Ridge, Ohio, was removed in 1977 after 12 years and 9 months of continuous service (ref. 13). A photograph of the tank after removal is shown in figure 18. The exterior surface of the tank ends and the center joints had a white, somewhat chalky film, which easily scrubbed off with an abrasive cleaner. This surface effect was typical of air-cured fiberglass surfaces exposed to moisture over long periods of time. No areas of cracking or crazing were found on the inner surface.

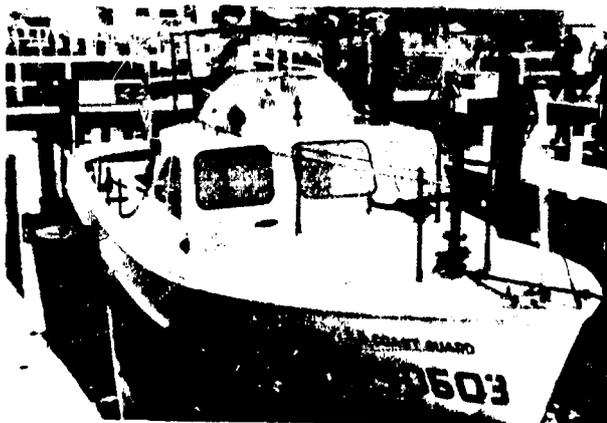
Figure 21. - 40-Foot Coast Guard patrol boat with fiberglass hull. (Photo courtesy of Owens-Corning Fiberglas Corp.)

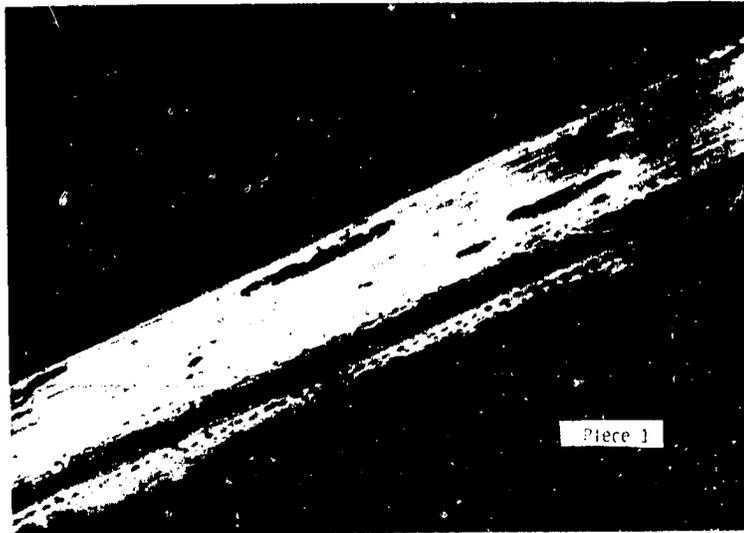
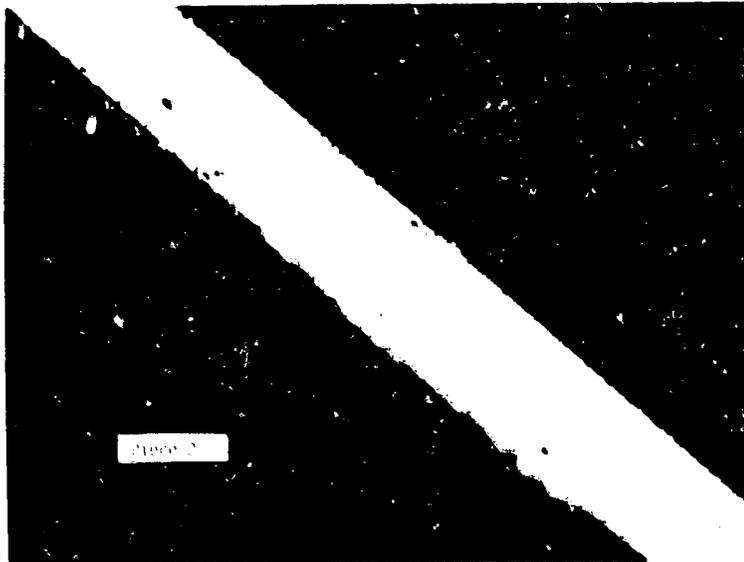
(a) Laminate sections, 1962.

Figure 22. - Cross sections of hull laminates of Coast Guard patrol boat after 10 and 19 years of continuous service. (Photo courtesy of Owens-Corning Fiberglas Corp.)

(b) Laminate sections, 1971.
Figure 22 - concluded.

A comparative study of similar tests from these two samplings conducted in 1962 and 1972 is described in reference 14. Visual examination of the removed panels showed no evidence of deterioration due to age or environment (fig. 22). There was no discoloration beyond the first millimeter of thickness, and there was no indication of water or other contaminants penetrating the small number of voids in the laminate.

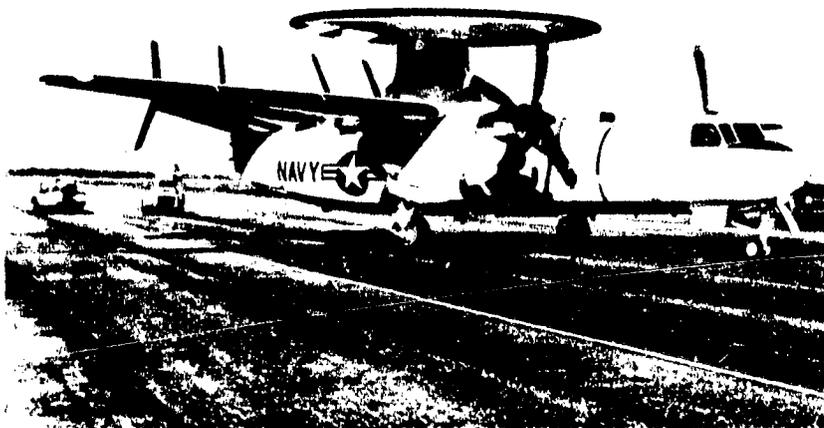
(a) Aircraft.

(b) Close-up view of rotodome.

Figure 24. - Fiberglass laminate rotodome
installed on Grumman E-2A aircraft.
(Photo courtesy of Grumman Aerospace Corp.)

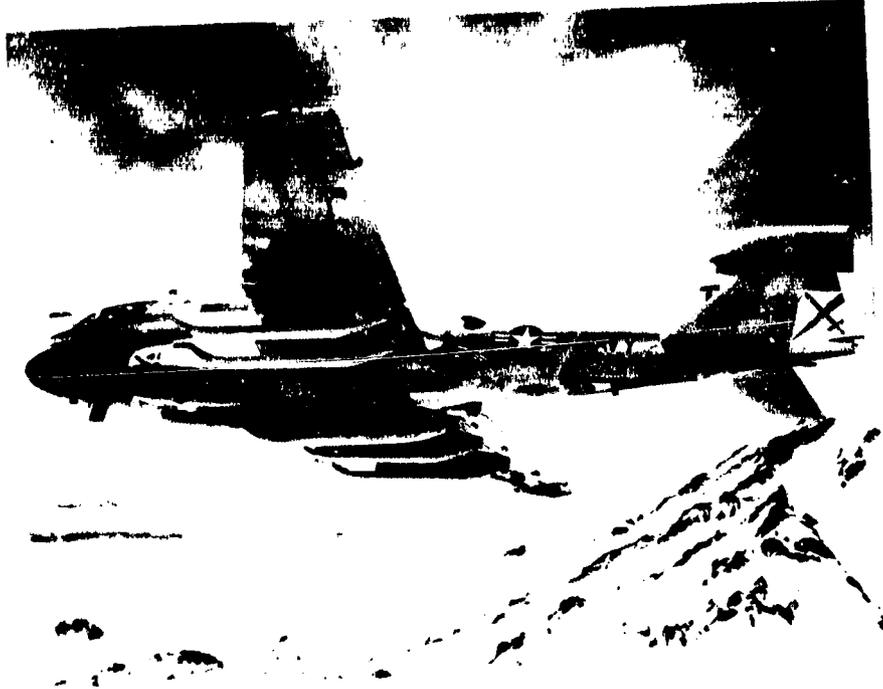
(a) Aircraft.

(b) close-up view of radome.

Figure 25. Helikent wound fiberoptic nose radome on
 Grumman A-1 aircraft. (Photo courtesy of Ground
 Release Corp.)
